NORTHERN REGION JOINT MUNICIPAL COMPREHENSIVE PLAN

ROAD NAME: Carlisle Road (SR-0074)
MUNICIPALITY: Carroll Township; Dillsburg Borough

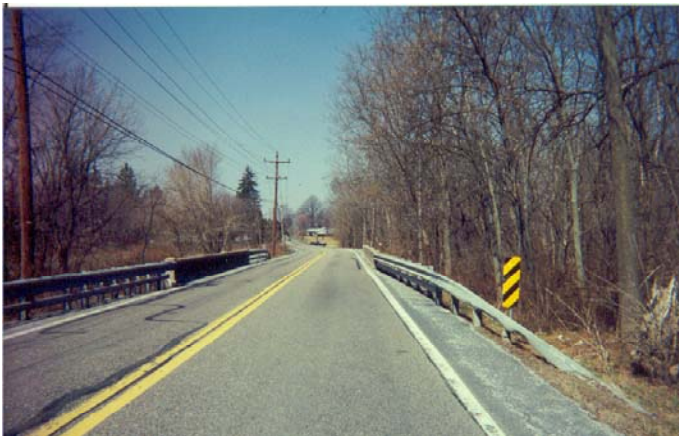
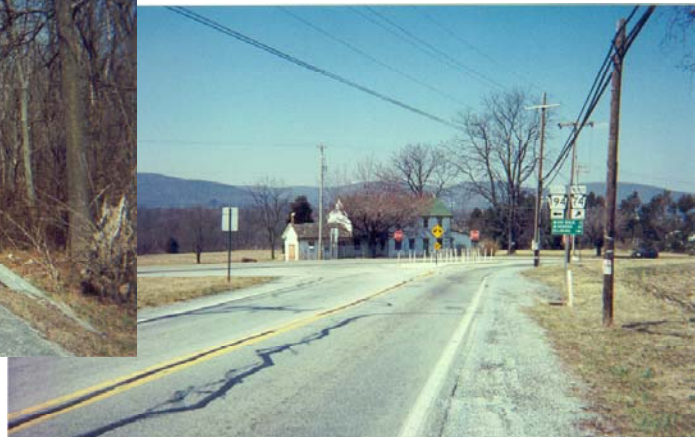
- Narrow Shoulders (0 to 2 foot width), Township Line to Northern High School;
- Fair to poor roadway conditions with cracked pavement and potholes;
- Narrow bridge prior to Campground Road intersection with old concrete parapets;
- Unconventional intersection with SR 0094;
- Traffic congestion problems at intersection with Campground Road;
- “Wet Pavement” crash cluster , Township Line to Tannery Road.
