NORTHERN REGION JOINT MUNICIPAL COMPREHENSIVE PLAN

ROAD NAME: Mountain Road/Harrisburg Street/Harrisburg Pike (SR-4040)
MUNICIPALITY: Franklin Township; Carroll Township; Dillsburg Borough

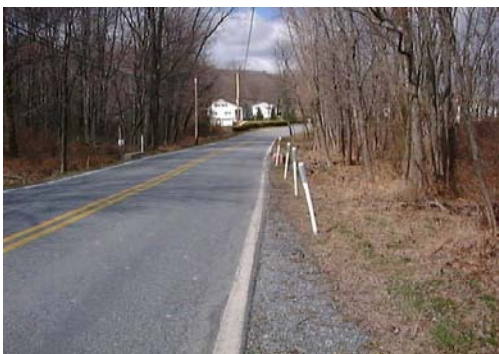
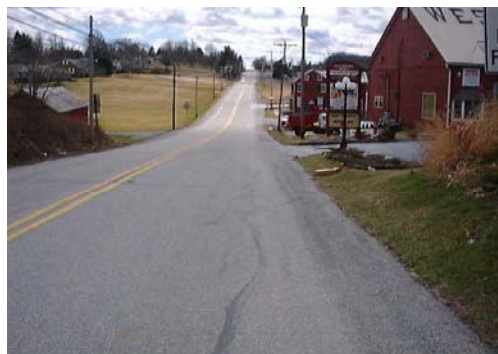
Field observations and discussions with municipal personnel identified the following roadway deficiencies on Mountain Road/Harrisburg Street/Harrisburg Pike:

- Pavement edge failures;
- Pavement failures on bridge at SR-0015 intersection;
- Narrow bridge with headwalls 8-10 inches high;
- Slippery When Wet sign indicating Wet Pavement Cluster and problem;
- Deer Crossing sign indicating a hit deer problem;
- Concerns in the vicinity of the new elementary school, South Mountain Elementary.
